Survey Report On

Lavendale, Finstown, Orkney, KW17 2JX.

Date of inspection: 5th November 2024.

Prepared by: Christopher Park, M.R.I.C.S.,

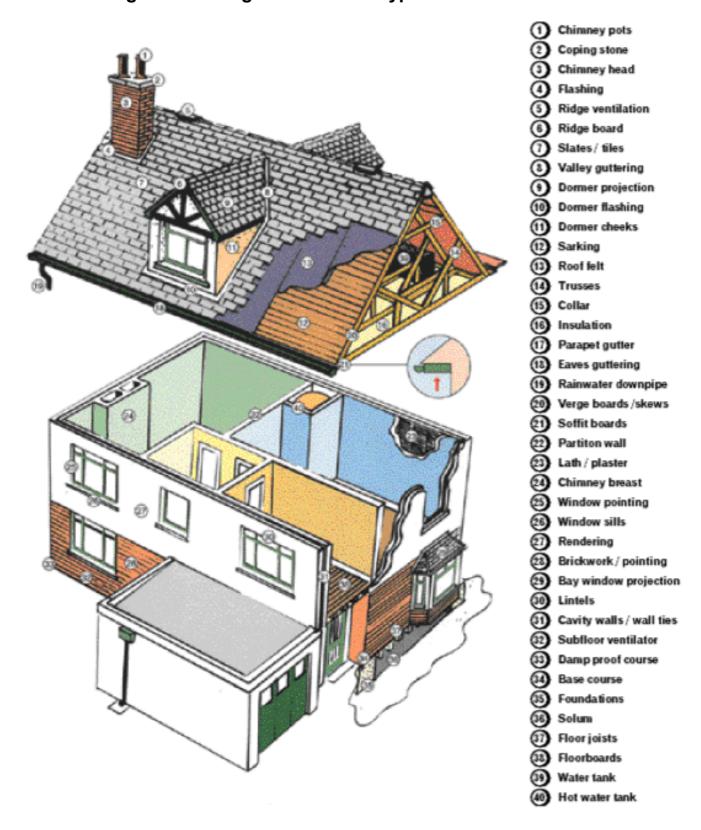
Sectional diagram showing elements of a typical house

Reference may be made in this report to some or all of the above component parts of the property. This diagram may assist you in locating and understanding these terms.
