## Survey Report On

**8 Garson Drive,  
Stromness,  
Orkney,  
KW16 3JG.**

**Date of inspection:** 17<sup>th</sup> December 2024.

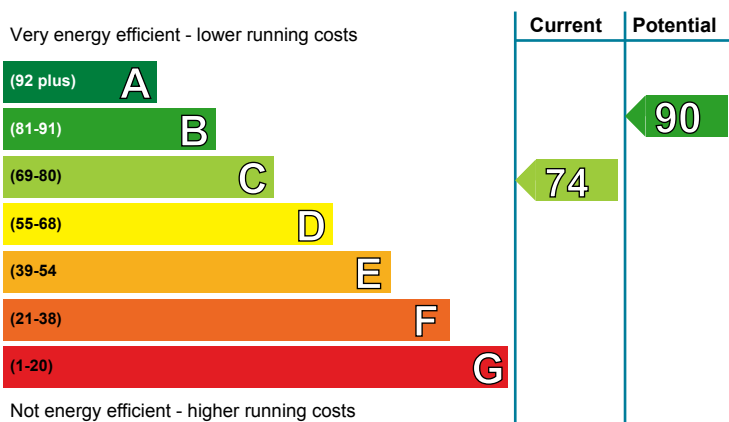
## Energy Efficiency Rating

This graph shows the current efficiency of your home, taking into account both energy efficiency and fuel costs. The higher this rating, the lower your fuel bills are likely to be.

Your current rating is **band C (74)**. The average rating for EPCs in Scotland is **band D (61)**.

The potential rating shows the effect of undertaking all of the improvement measures listed within your recommendations report.

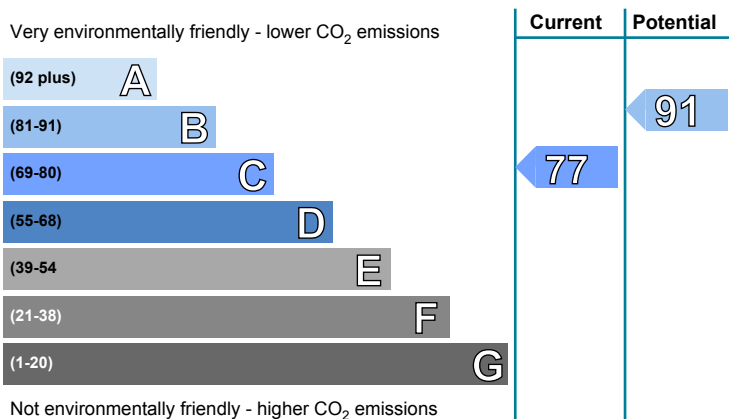
## Environmental Impact (CO<sub>2</sub>) Rating

This graph shows the effect of your home on the environment in terms of carbon dioxide (CO<sub>2</sub>) emissions. The higher the rating, the less impact it has on the environment.
